Coal Mine Fatal Accident 2003-25-26

Operator:	Progress Coal (Massey Energy Company)
Mine:	Twilight MTR Surface Mine
Accident Date:	September 17, 2003
Classification:	Powered Haulage
Location:	District 4, Boone County, WV
Mine Type:	Surface
Employment:	153
Production	19,000 tons/day

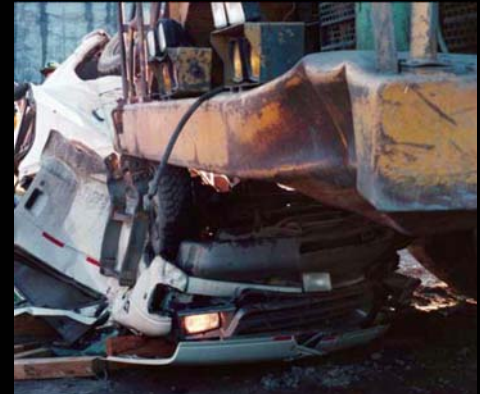
- The rock truck driver looked toward the track-hoe (which the van driver was scheduled to operate that shift), saw its illuminated dome light, and assumed that he had called from the track-hoe.
- He moved forward with the intent of going to the track-hoe to pick up his supplies, driving his right front bumper and tire into the portal van.
- The driver of the rock truck behind the van heard the radio transmission, looked toward the other truck, saw the van being shoved sideways, and shouted over the radio for the rock truck to stop.
- By the time the truck stopped, the van had rolled over onto its roof and was crushed under the rock truck's bumper/frame and right front tire.

- As the rock truck continued forward, the van rolled over onto its roof and was crushed under the truck's bumper/frame and the right front tire. Tire tracks indicated the truck moved forward ~32' before stopping (~1 truck tire revolution).

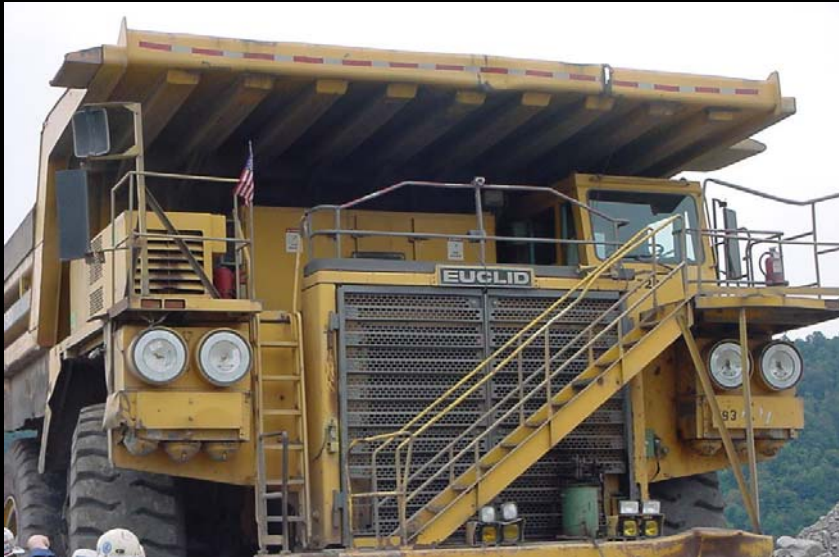
EUCLID R190 ROCK TRUCK

- A blind spot extended ~60' to the ground on the truck's front, right side.
- Another blind spot extended ~240' directly to the driver's right side.
- A camera system was installed on the truck consisting of 3 cameras and a monitor.
- The cameras provided a view of the blind areas to the front, off-side, and rear.

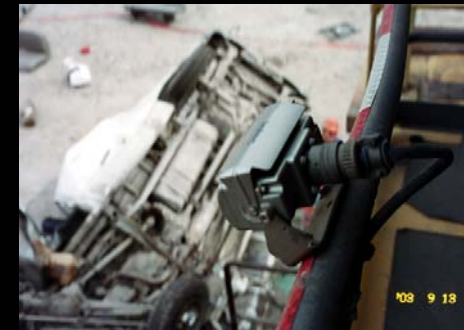
Front Camera shown overlooking crushed van.

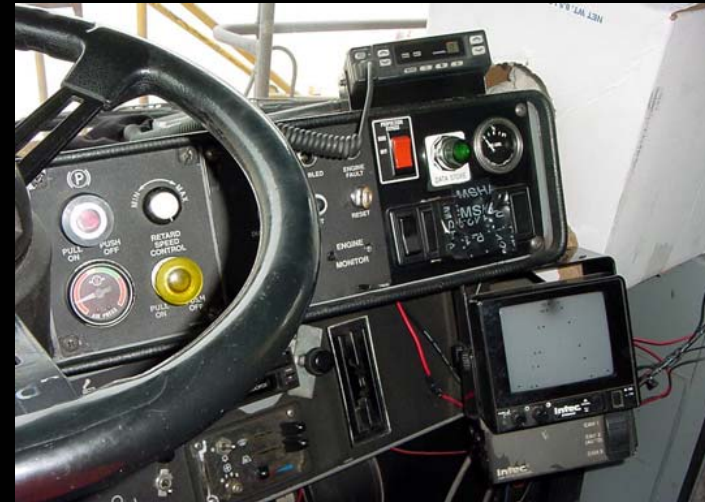
- Since the truck was moving straight forward, the front camera view should have been selected to show the intended direction of travel. However, since the camera system was in standby mode, the monitor remained off as the truck moved forward.

- Equipment operators will have cameras turned toward the direction of intended travel and foreman and manager vehicles will use strobe lights in poor visibility, low light levels, and at night.

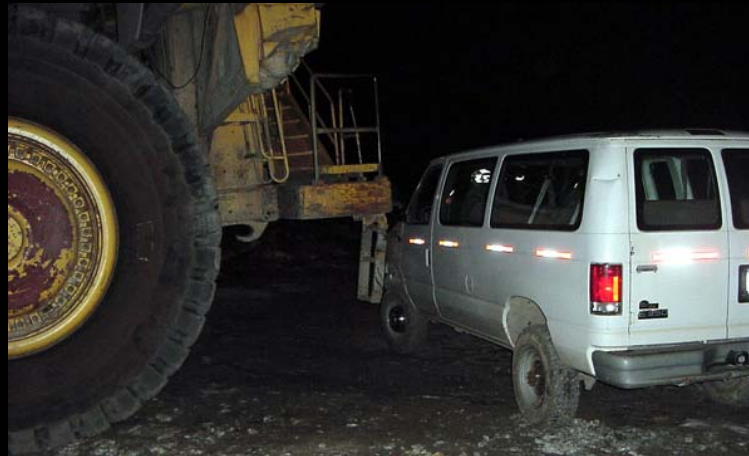
ACCIDENT RE-CREATION

- A re-creation of the conditions and events leading up to the accident was conducted using the rock truck involved in the accident and an identical van.
- The re-creation was conducted at ~6:00 a.m., at which time outdoor conditions were dark and the weather was clear, similar to the morning of the accident.
- The van approached the parked rock truck from the off-side and stopped in front of the truck, simulating the path of the van involved in the accident.
- The van's headlights were visible from the rock truck driver's seat. When the strobe light was used, flashes on the truck's handrail were also visible from the cab of the rock truck.

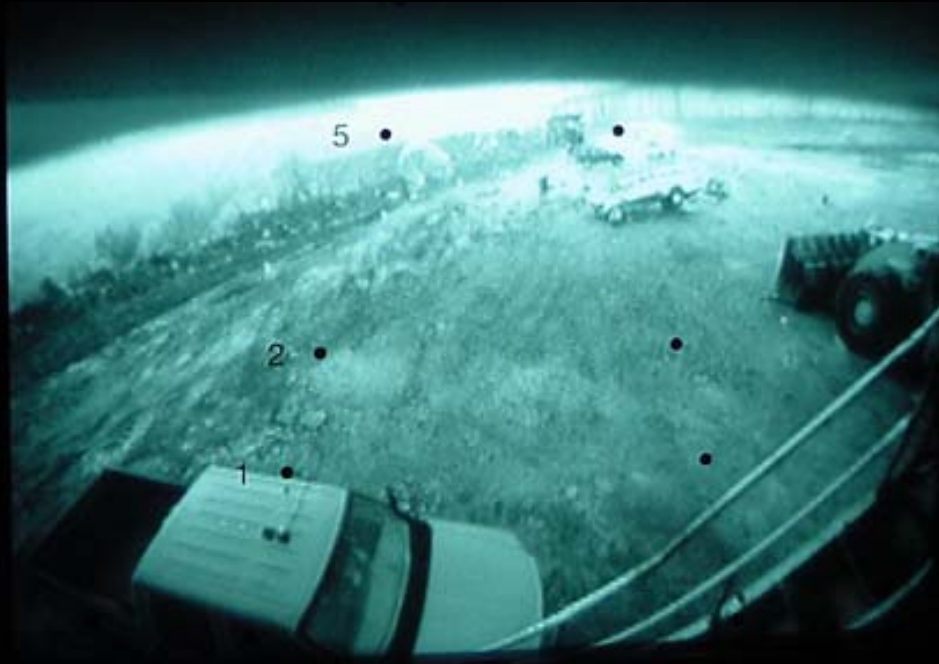
ACCIDENT RE-CREATION

- After portal van stopped, it was clearly visible on the monitor in the front camera view. Use of the strobe light enhanced this view.
- Radio communications between the van and truck functioned properly.
- The dome light of the track-hoe was clearly visible from the truck cab.
- The rock truck horn operated properly.
